Formation of Structural Defects in AlGaN/GaN High Electron Mobility Transistors under Electrical Stress

Prashanth Makaram¹, Jungwoo Joh², Carl V. Thompson¹
Jesús A. del Alamo² and Tomas Palacios²

¹Material Processing Center ²Microsystems Technology Laboratories
Massachusetts Institute of Technology, Cambridge, MA, USA

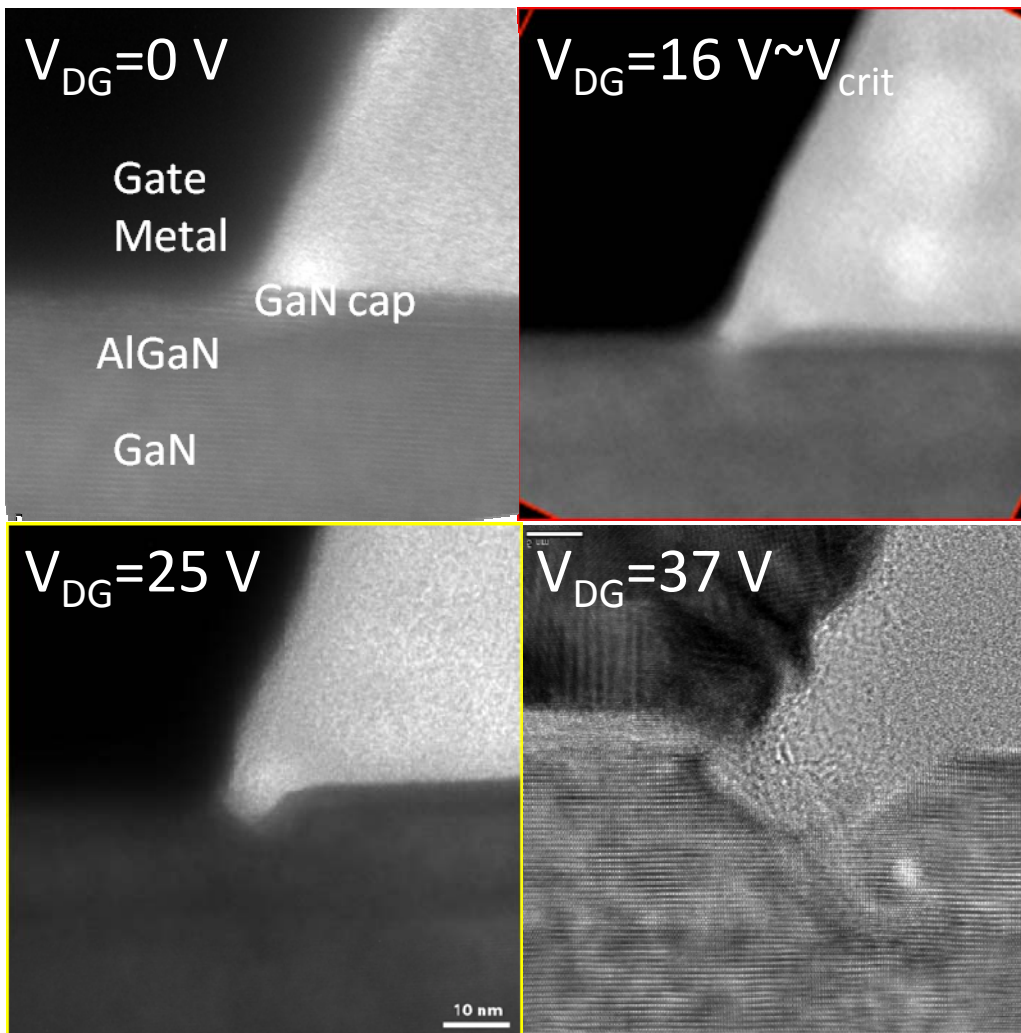
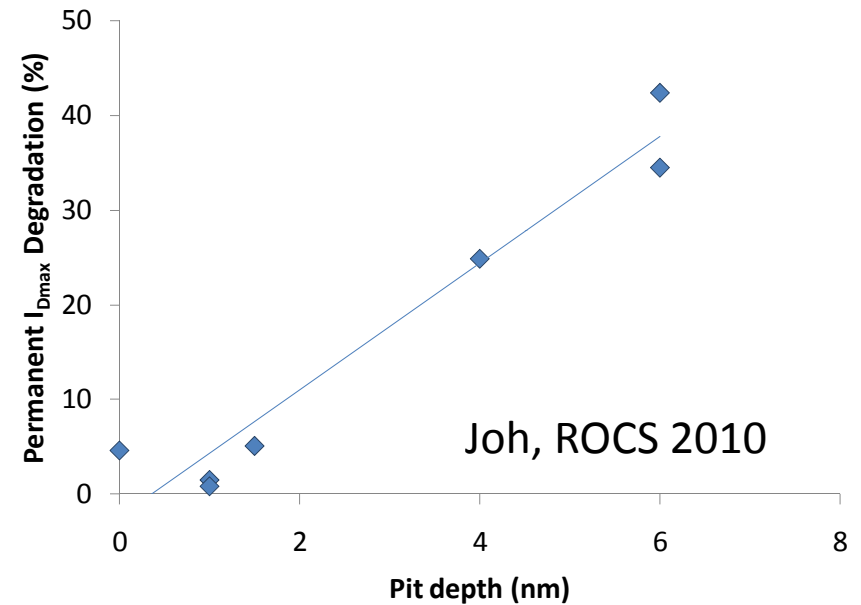
Good correlation between pit depth and electrical degradation

Initial dimple followed by deeper pitting and cracking.

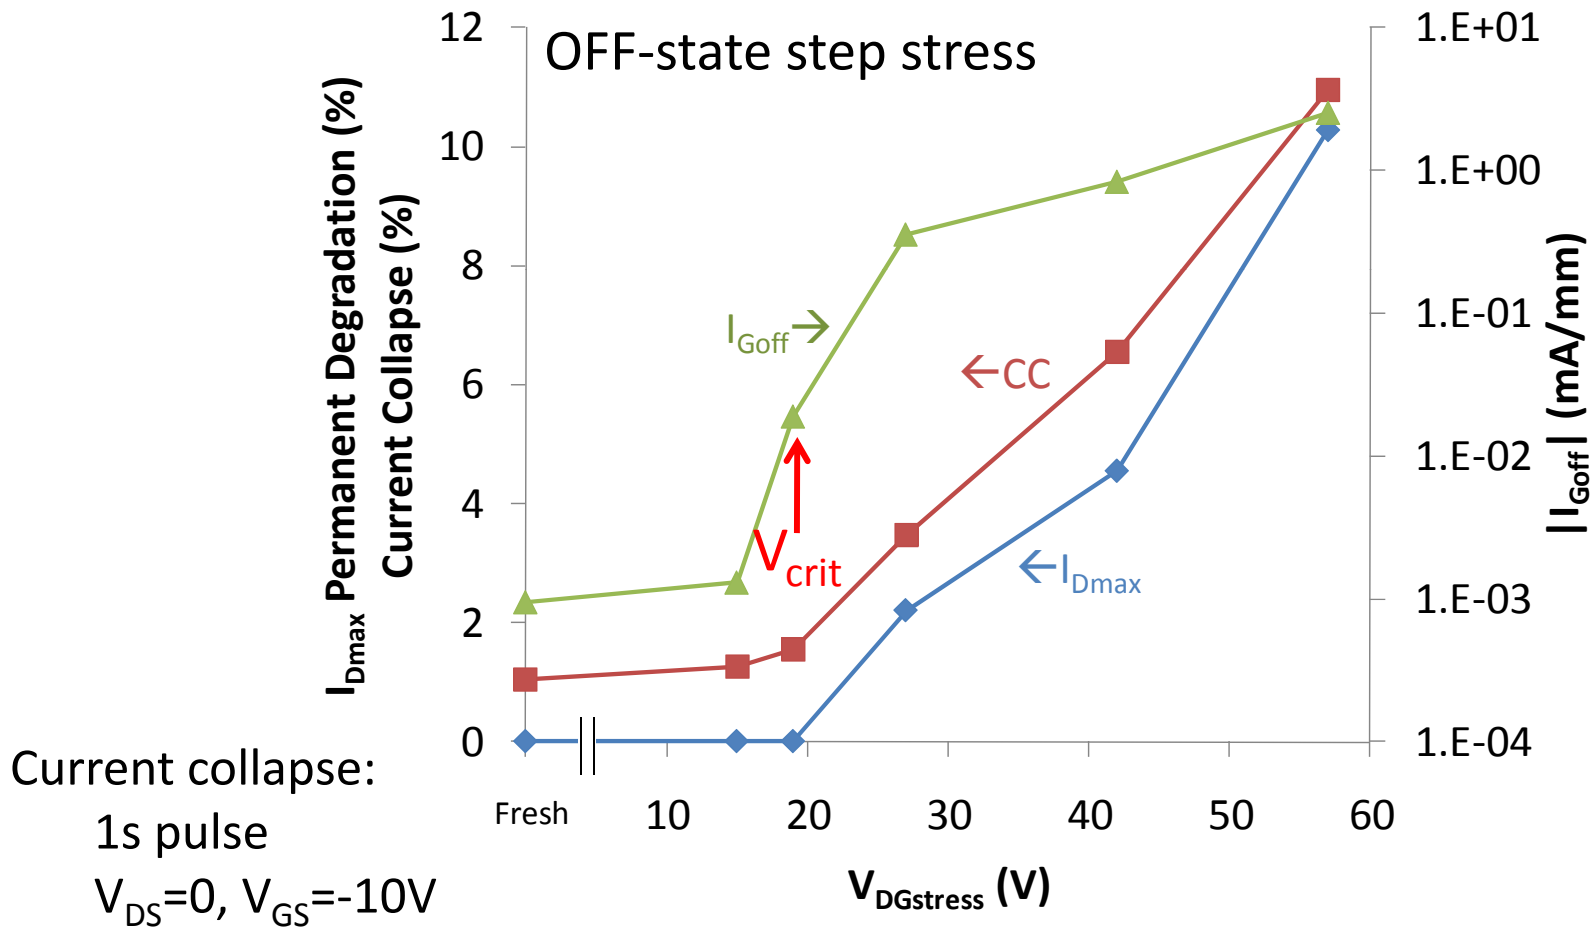
Typical **critical behavior** beyond 19 V

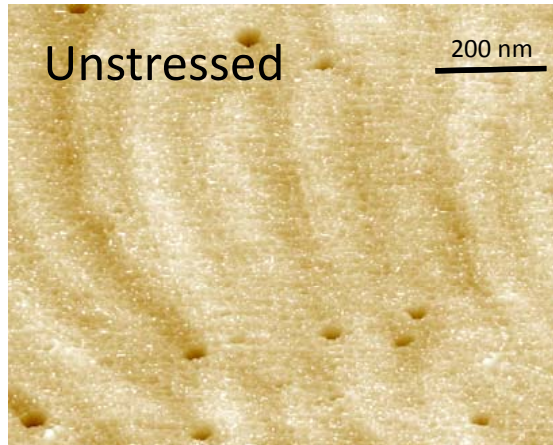
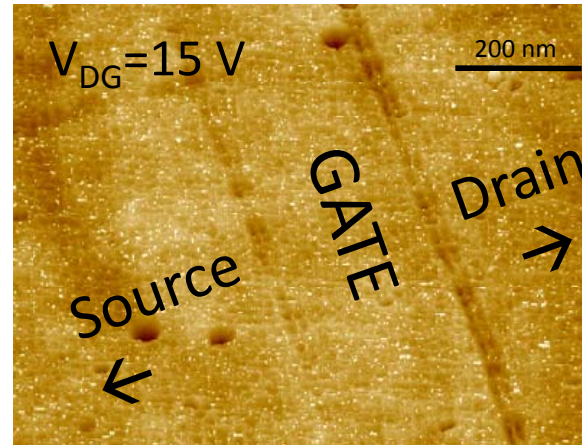
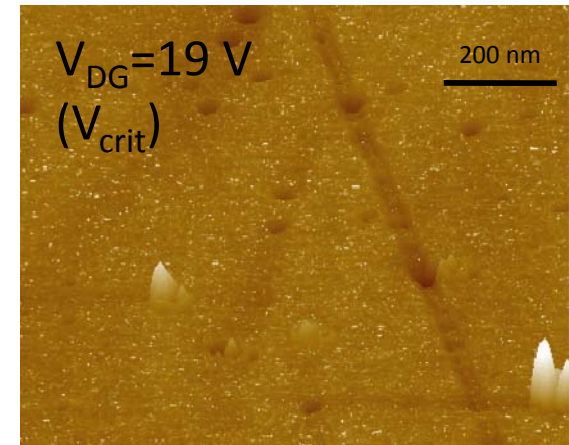
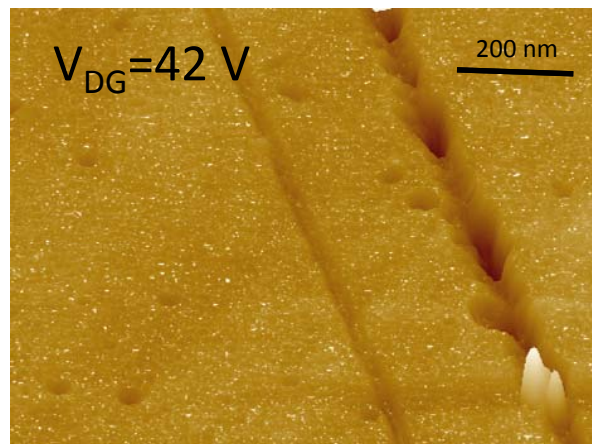
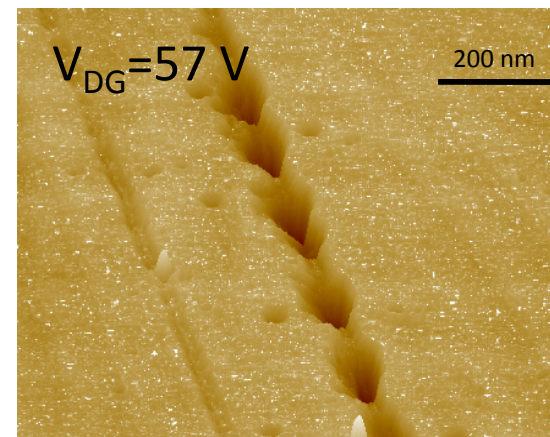
Initial continuous **groove** formation
Deeper **pit** formation along the groove

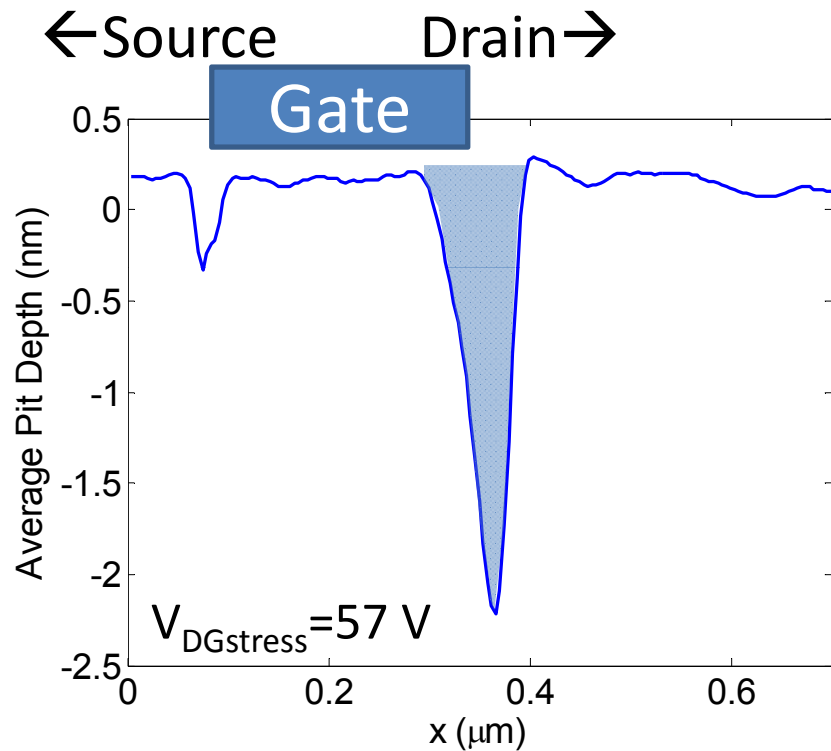
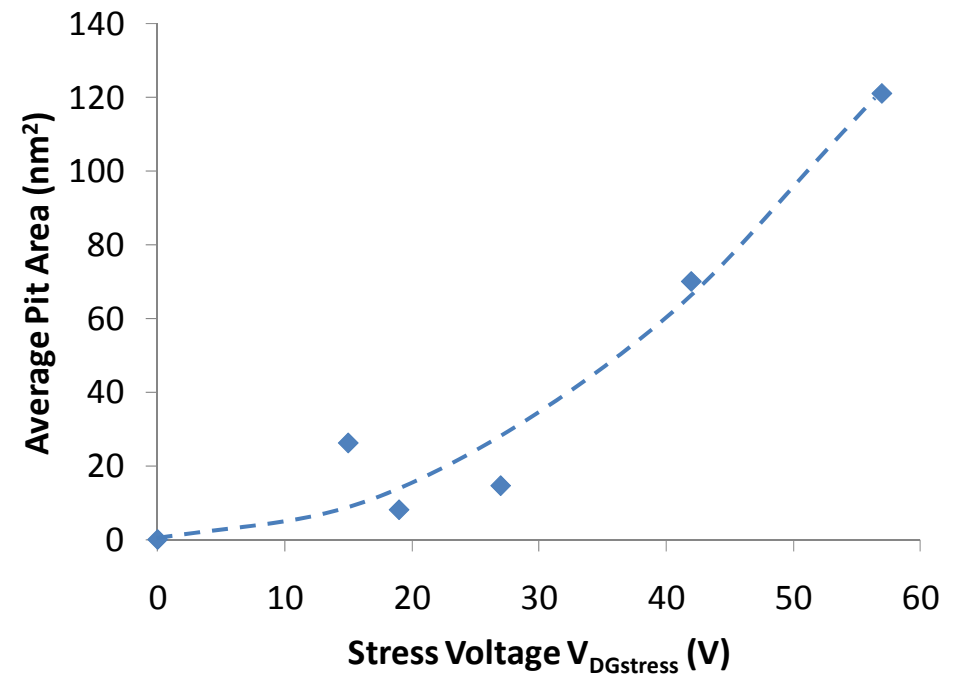
Drain side pit area also shows critical behavior.

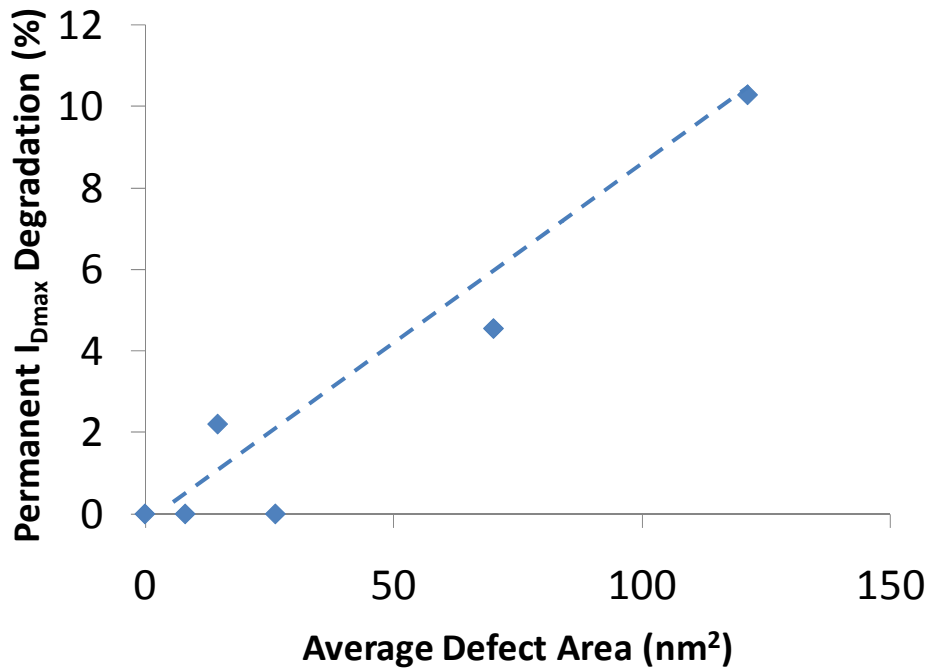
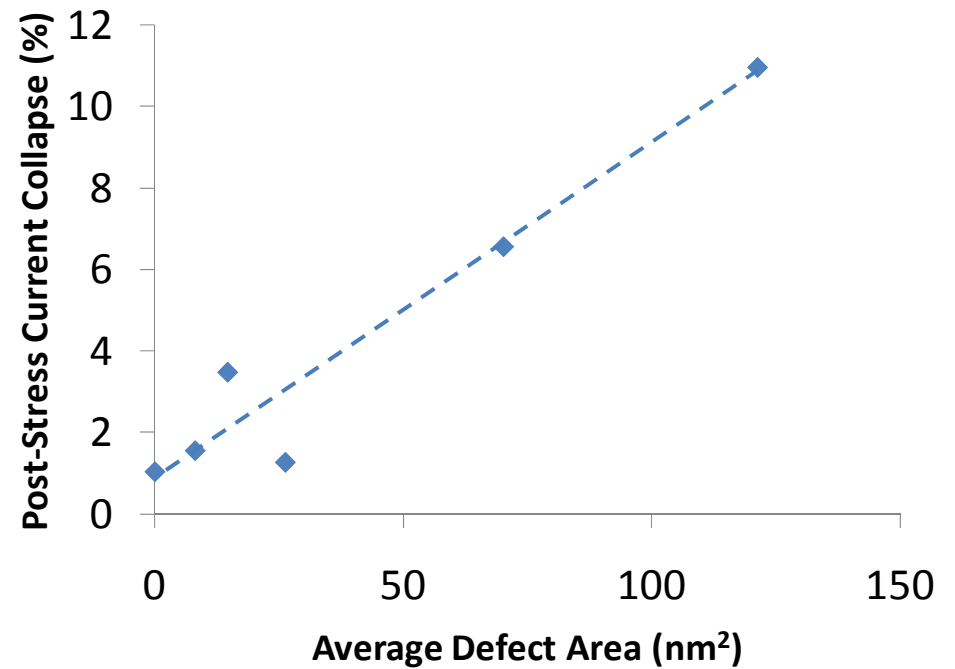
Good correlation between electrical degradation and pit area

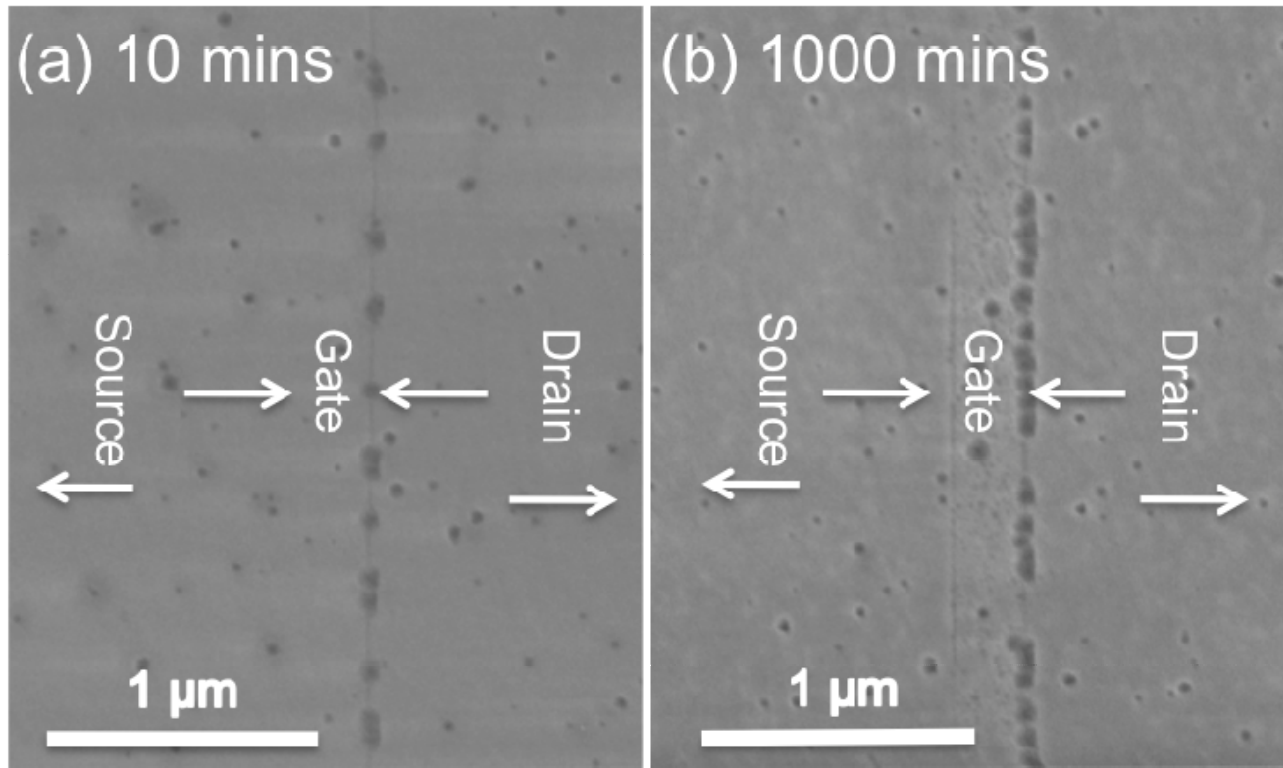
Source side **groove** formation

Pits grow in density and merge with each other.

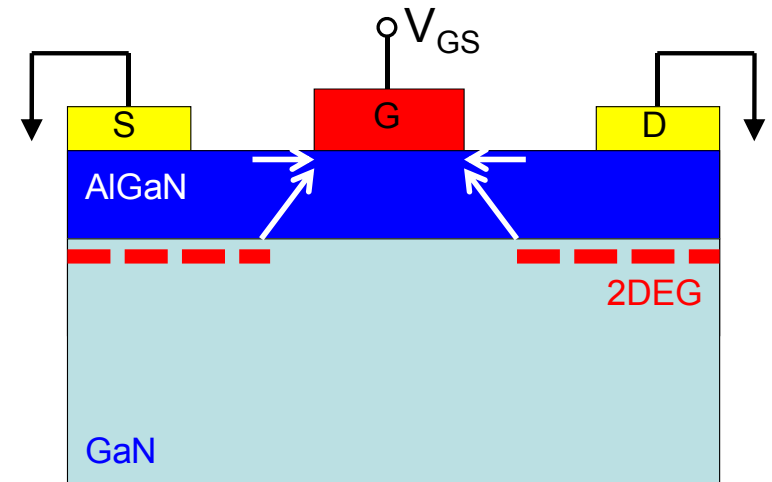
Grooves and pits on both sides of the gate
