Evolution of structural defects associated with electrical degradation in AlGaN/GaN high electron mobility transistors

We have investigated the surface morphology of electrically stressed AlGaN/GaN high electron mobility transistors using atomic force microscopy and scanning electron microscopy after removing the gate metallization by chemical etching. Changes in surface morphology were correlated with degradation in electrical characteristics. Linear grooves formed along the gate edges in the GaN cap layer for all electrically stressed devices. Beyond a critical voltage that corresponds to a sharp increase in the gate leakage current, pits formed on the surface at the gate edges. The density and size of the pits increase with stress voltage and time and correlate with degradation in the drain current and current collapse. We believe that high mechanical stress in the AlGaN layer due to high-voltage stressing is relieved by the formation of these defects which act as paths for gate leakage current and result in electron trapping and degradation in the transport properties of the channel underneath. © 2010 American Institute of Physics. [doi:10.1063/1.3446869]

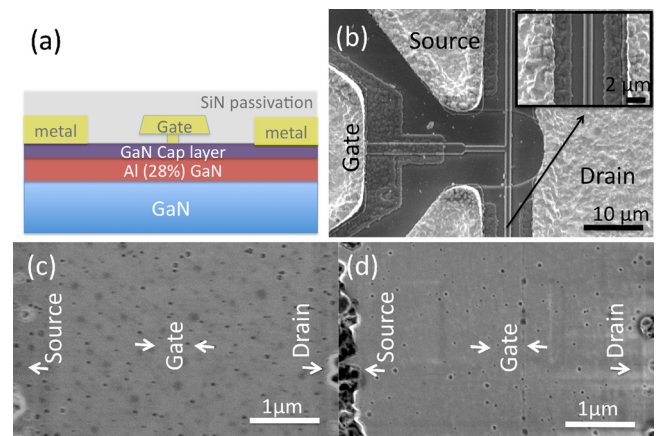
FIG. 1. (Color online) SEM micrographs and schematic of the device. (a) Cross section of the device showing the different layers. (b) Top view of the device before etching. [(c) and (d)] Micrographs of the gate area of unstressed and stressed devices ($V_{DG}=20$ V), respectively, after metal removal.

are expected in the virgin material, this material removal process did not introduce any damage to the surface of the device [Fig. 1(c)]. The footprint of the gate wasn't visible either. In contrast, heavily stressed devices, as in Fig. 1(d), show a clear row of pits along the gate edge on its drain side.

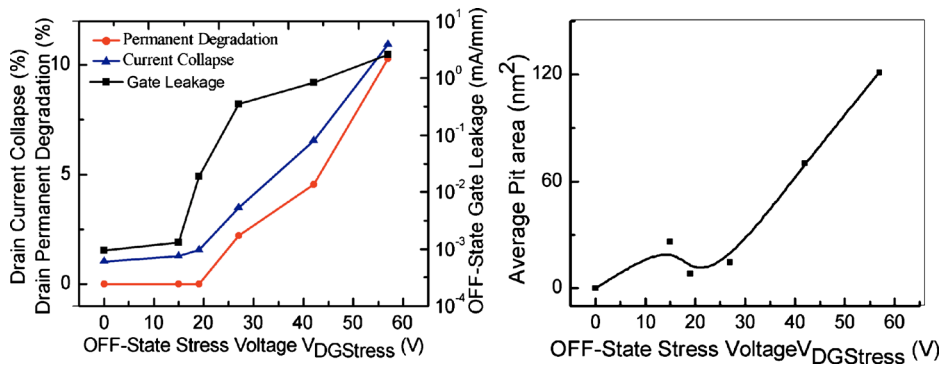
FIG. 2. (Color online) (a) Electrical figures of merit as a function of $V_{DGStress}$: percent decrease in uncollapsed I_{Dmax} (drain current permanent degradation) and percent increase in current collapse (left scale) and absolute value of off-state gate leakage current (right scale). (b) Average pit area vs stress voltage $V_{DGStress}$ in the same experiment. $V_{DGStress}=0$ indicates the unstressed device.

Identical devices from the same chip were step-stressed at $V_{GS}=-7$ V with increasing values of V_{DG} from 8 to 50 V, with a step size of 1 V (stressed for 1 min at each step) at a base-plate temperature of 150 °C. We determined that, under these conditions, the critical voltage V_{crit} at which a sharp increase in the gate current occurred⁷ was around 20 V [Fig. 2(a)]. Beyond V_{crit} there was significant permanent decrease in I_{Dmax} , of up to 10%, as well as a large increase in current collapse [Fig. 2(a)].

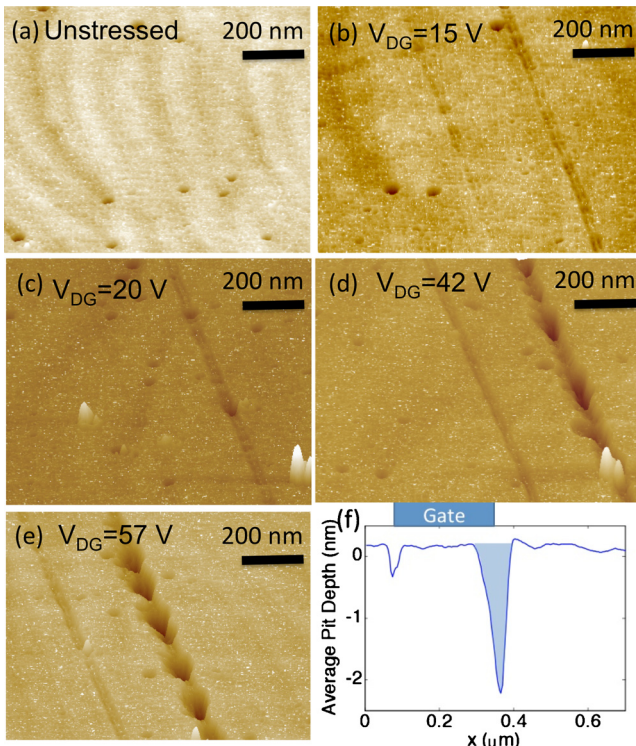
AFM scans (Fig. 3) showed that below V_{crit} a groove developed in the GaN cap layer at the drain side of the gate extending the entire length of the device [Fig. 3(b)]. A very faint and discontinuous groove is also detectable on the source side. In unstressed devices [Fig. 3(a)], other than

as-grown pits, the surface is smooth under the gate and no groove was observed. For devices stressed at higher voltages, the groove on the source side becomes more apparent [Figs. 3(d) and 3(e)]. For stress voltages beyond V_{crit} , localized pits formed along the groove line, and their density and size increased with an increase in $V_{DGStress}$ [Figs. 3(d) and 3(e)]. For the most heavily degraded devices, these pits penetrate into the AlGaIn layer and are as deep as 8 nm, as seen from AFM scans averaged over a gate width of 2 μm [Fig. 3(f)]. The actual depth might be much higher due to the small planar dimensions of the pits compared to the AFM tip radius. Similar groove and pit formation was observed across many devices from different wafers.

FIG. 3. (Color online) Progressive structural damage with voltage stress (a) unstressed device, (b) $V_{DGStress}=15$ V $< V_{crit}$, (c) $V_{DGStress}=20$ V $\cong V_{crit}$, (d) $V_{DGStress}=42$ V, and (e) $V_{DGStress}=57$ V. (f) Averaged AFM depth profile over a gate width of 2 μm for the most degraded device ($V_{DGStress}$ = 57 V).

At the critical voltage, AFM images [Fig. 3(c)] indicate that the groove in the GaN cap layer becomes deep and pits¹⁶ on the AlGaIn layer appear on the drain side. Some of these pits may form at nanopipes¹⁷ or v-defects¹⁸ that nucleate on pre-existing threading dislocations which have been established as paths for leakage current.^{19–21} However, the pits eventually appear at a density that exceeds the initial defect density, suggesting that new pits form without pre-existing defects. The simultaneous emergence of pits and the increase in gate leakage current at the critical voltage in our electrical measurements are consistent with the electrical characteristics of pits reported in the literature.^{17–19}

In the as-grown heterostructure, the top AlGaIn layer is under tensile stress due to lattice mismatch with the GaN buffer. The application of a high negative voltage to the gate increases the stress near the gate edge because of the inverse piezoelectric effect.²² The local stress can be relieved by an increase in the pit density and size.²³ The stress around these pits is generally high enough to generate cracking,²⁴ likely toward a nearby pit. The appearance of pits and cracks reduces the maximum drain current and introduces trapping centers that contribute to current collapse. In fact, the average cross-sectional pit area computed along the gate width [defined as the shaded area in Fig. 3(f)] correlates well with the degradation in drain current and current collapse [Fig. 2(b)].

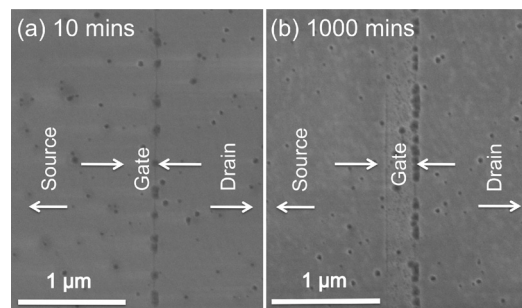
Devices were also stressed at $V_{DG}=50$ V for different time periods. As the stress time increases, we observe an increase in the number of pits and a merging of the pits with each other to form a continuous defective region along the gate (Fig. 4). This is consistent with a larger electrical degradation in the device stressed for longer time. The current collapse and permanent drain current degradation increased from 5.1% and 5.6% at 10 min to 17.8% and 26.6% at 1000 min, respectively. The pattern of the defective region and its correlation with electrical degradation are consistent with the electroluminescence results of Ref. 11.

FIG. 4. SEM images of the pits after stressing at $V_{DGStress}=50$ V for (a) 10 min and (b) 1000 min.
