Formation of Structural Defects in AlGaN/GaN High Electron Mobility Transistors under Electrical Stress

Prashanth Makaram¹, Jungwoo Joh², Carl V. Thompson¹
Jesús A. del Alamo² and Tomas Palacios²

¹Material Processing Center ²Microsystems Technology Laboratories
Massachusetts Institute of Technology, Cambridge, MA, USA

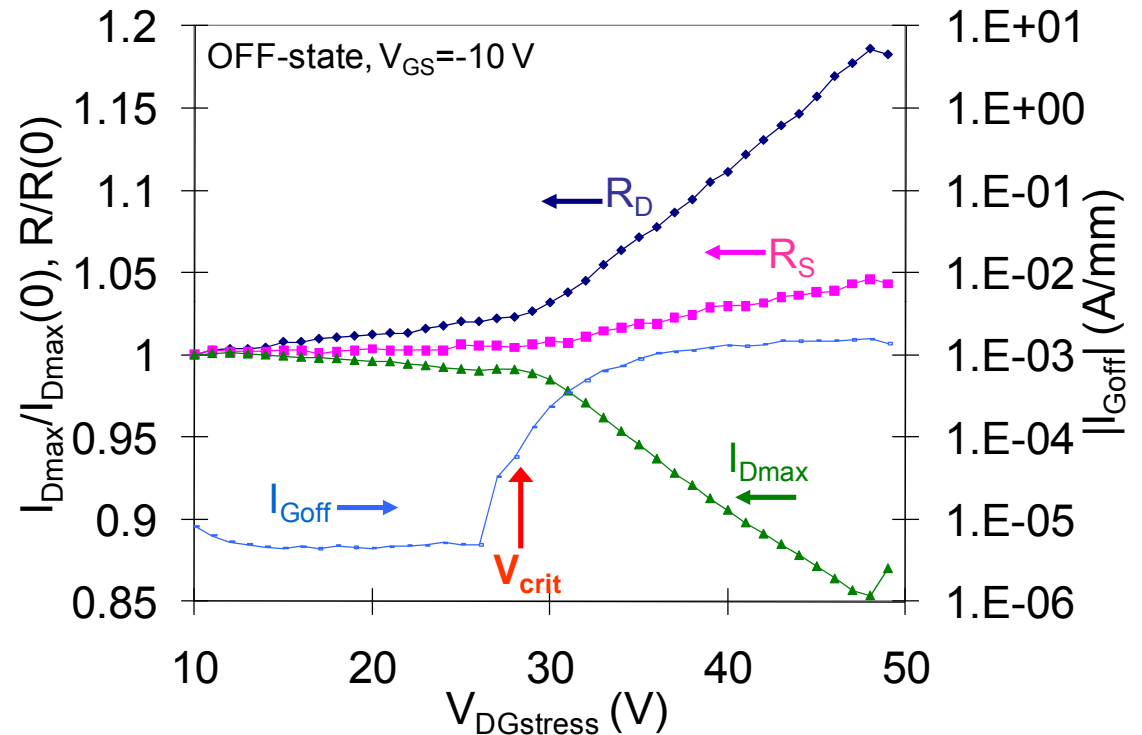
I_{Dmax} : $V_{DS}=5$ V, $V_{GS}=2$ V I_{Goff} : $V_{DS}=0.1$ V, $V_{GS}=-5$ V

I_D , R_D , and I_G start to degrade beyond **critical voltage (V_{crit})**
(+ trapping behavior – current collapse)

Common physical origin in I_D and I_G degradation

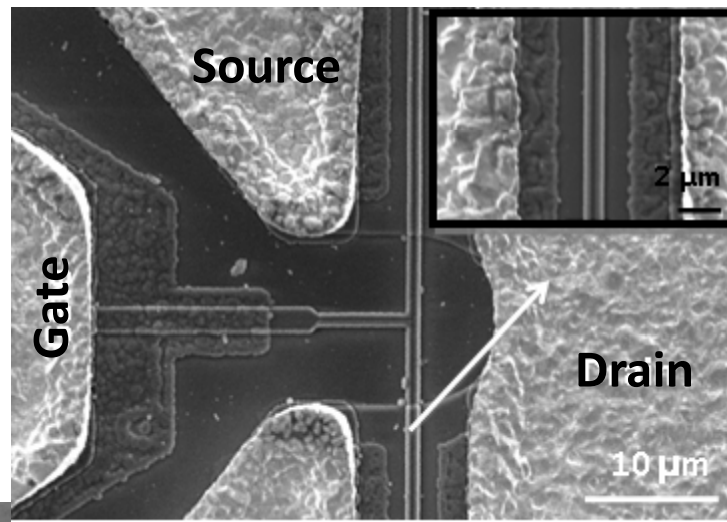
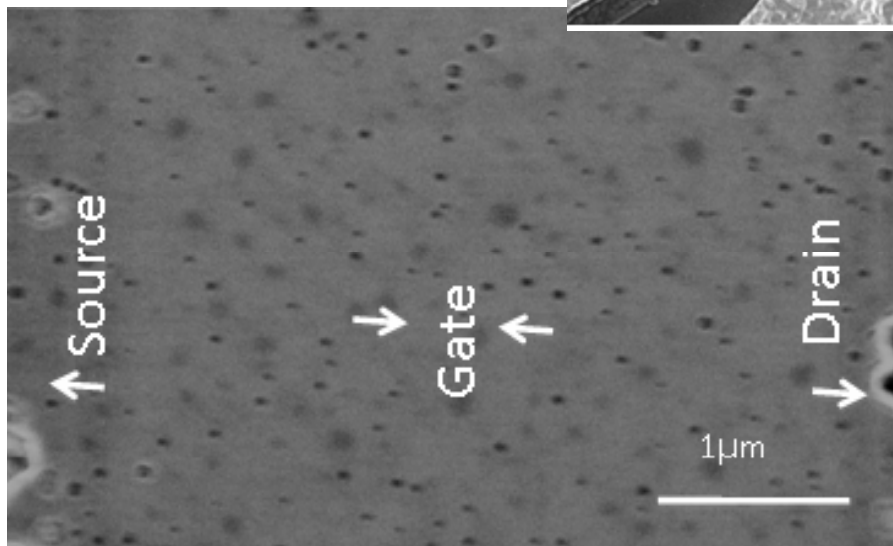
Unstressed (high T storage)

Stressed ($> V_{\text{crit}}$)

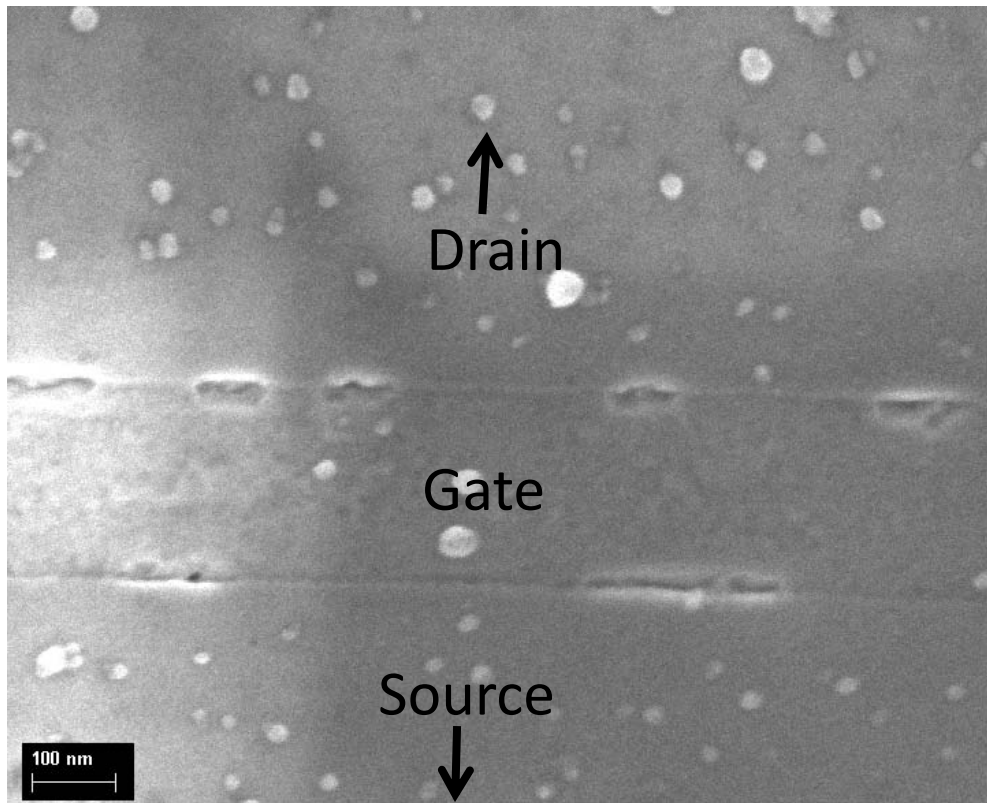
Stress conditions:

- $V_{DS}=0$, $V_{GS}=-50$ V
(stressed on both sides)
- 40 min.
- Room temperature

Grooves and pits on both sides of the gate
