## Spatial distribution of structural degradation under high-power stress in AlGaIn/GaN high electron mobility transistors

The two-dimensional spatial distribution of structural degradation of AlGaIn/GaN high electron mobility transistors was investigated under high-power electrical stressing using atomic force and scanning electron microscopy. It was found that pits form on the surface of the GaN cap layer at the edges of the gate fingers in the middle of the device. The average pit area and density increase gradually from the edge to the center of the fingers and are more common along inner fingers than fingers. It was also found that pit formation and growth are thermally activated. © 2012 American Institute of Physics. [<http://dx.doi.org/10.1063/1.4707163>]

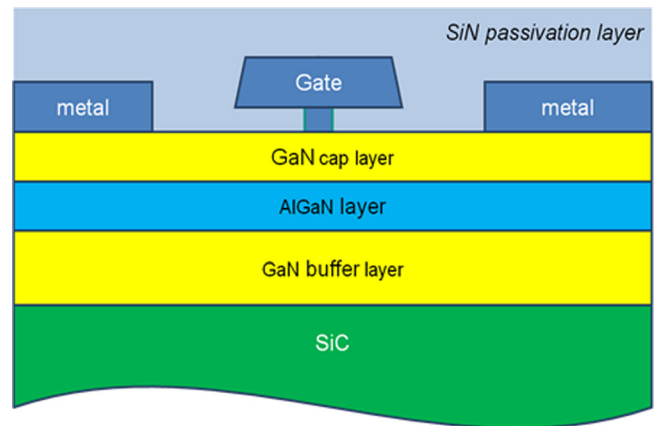
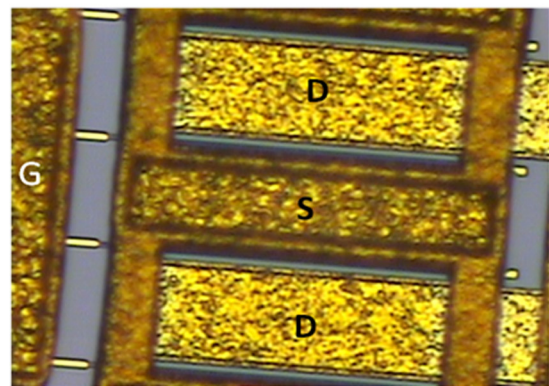
Figure 1 shows the device structure. An AlGaIn/GaN heterostructure was grown on a SiC substrate using metal-organic chemical vapor deposition. The heterostructure includes a thin GaN capping layer that protects the AlGaIn barrier layer and reduces the chance of oxidation or crack formation caused by

FIG. 1. Cross section of the device (top). Top-view, optical micrograph of the tested device with four 100  $\mu\text{m}$  wide gate fingers, before etching (bottom).

the inverse piezoelectric effect. The tested device has four  $100\ \mu\text{m}$ -wide fingers (Fig. 1, right). Further details of the device structure are given in Ref. 18. Due to the symmetric nature of the device geometry, we have analyzed one half each of one of the inner and outer fingers. Two different devices were studied yielding essentially identical results.

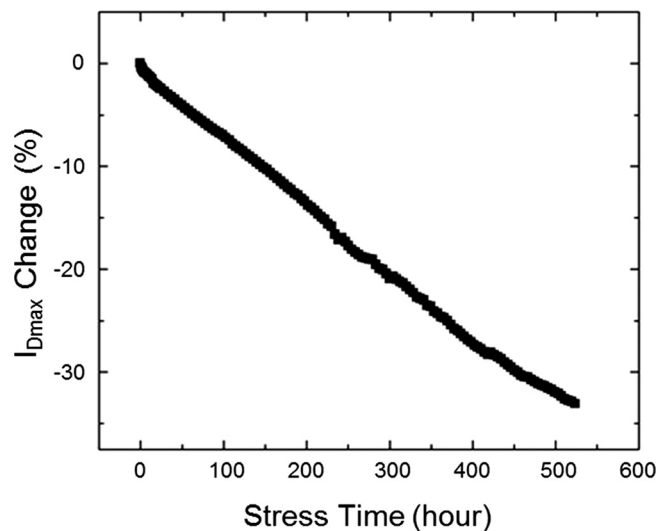
The devices were stressed in the high-power state with drain to source voltage  $V_{\text{DS}} = 40\ \text{V}$  and quiescent drain current  $I_{\text{DQ}} = 250\ \text{mA/mm}$  at a base-plate temperature of  $120\ ^\circ\text{C}$ . The stress time was 523 h. The maximum channel temperature under this stress condition was estimated to be around  $354\ ^\circ\text{C}$  from thermal simulations. These stress conditions are very harsh and far beyond the designed operational range of this device. They were selected to induce significant device degradation in a short span of time. This pit-related degradation mode has been observed in many devices stressed under a variety of conditions, including different bias conditions and temperatures.<sup>11,19</sup> The maximum current was recorded during the test by periodically interrupting the stress as shown in Figure 2.

FIG. 2. Change in maximum drain current  $I_{\text{Dmax}}$  as a function of stress time (stress conditions:  $I_{\text{DQ}} = 250\ \text{mA/mm}$ ,  $V_{\text{DS}} = 40\ \text{V}$ ,  $T_a = 120\ ^\circ\text{C}$ ). A decrease of 33% in  $I_{\text{Dmax}}$  was found after stressing for 523 h.

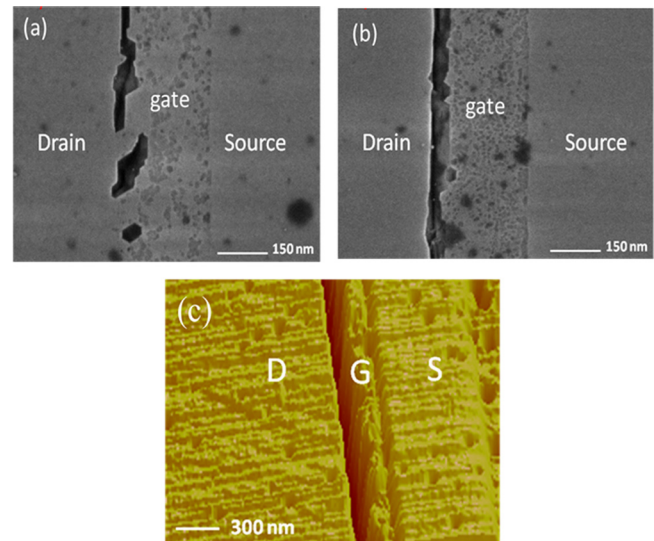
Figure 3 shows that pits formed along the drain-side edge of the inner finger, which is in agreement with our previous OFF-state studies.<sup>11</sup> Along the length of the finger, pits were found to be more likely to merge together (Figure 3(b)) near the center than towards the end (Figure 3(a)). The AFM images show that the pits merge and form trenches along the edge of the gate (Figure 3(c)), a typical width and depth of the trench is roughly  $50\ \text{nm}$  and  $8\ \text{nm}$ , respectively. The pit distribution along the finger suggests a thermal enhancement of the pit formation process. During electrical stressing, the temperature at the center is expected to be higher than in the periphery. Mechanical stress<sup>20</sup> and the high electric field at the drain side near the gate edge probably also play roles in driving the formation and growth of these pits. In the presence of an electric

FIG. 3. SEM [(a), (b)] and AFM (c) images of different locations along an inner finger after stressing; (a) close to the end of the finger, (b) near the central part of the finger, (c) a closer view from an oblique angle showing a deep trench in the GaN cap layer. Prominent pits are apparent under the drain side edge of the gate.

field, the pits grow through a process involving thermally activated atomic diffusion, so that elevated temperatures in the center of the device accelerate the rate of physical degradation.

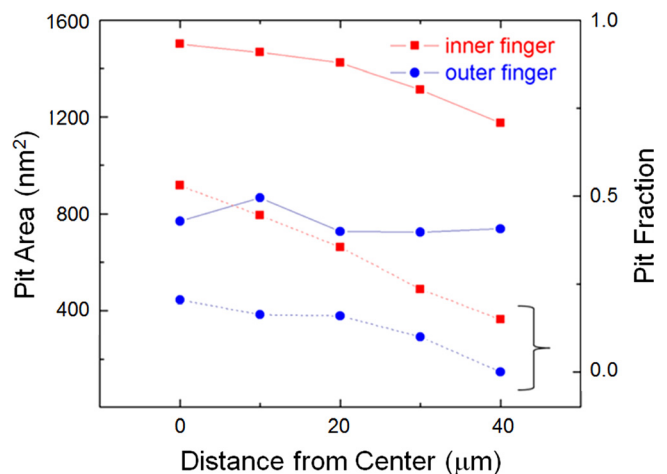
The average cross-sectional pit area and pit linear density along the inner and outer fingers, as observed using AFM, are plotted in Figure 4. The average pit area was evaluated along a  $10\ \mu\text{m}$  segment of the gate finger. The pit density was defined as the fraction of the gate edge occupied by pits that were deeper than  $7.5\ \text{nm}$  in each  $10\ \mu\text{m}$  long segment. The largest cross-sectional area of a single merged pit, as observed by AFM, was about  $1700\ \text{nm}^2$  (not shown on the figure). It should be noted that the defects present at the surface before stressing do not contribute to the measured pit area or density, due to their low depth and areal density. As Figure 4 shows, both the area and density of stress-induced pits markedly decrease from the center to the edge of the gate fingers and from the inner to the outer finger.

FIG. 4. Pit cross-sectional area and linear density as a function of location along the edge of the innercenter and outer fingers. The pit area and linear density decrease from the center to the end of the finger and are lower for the outer finger than the inner finger.

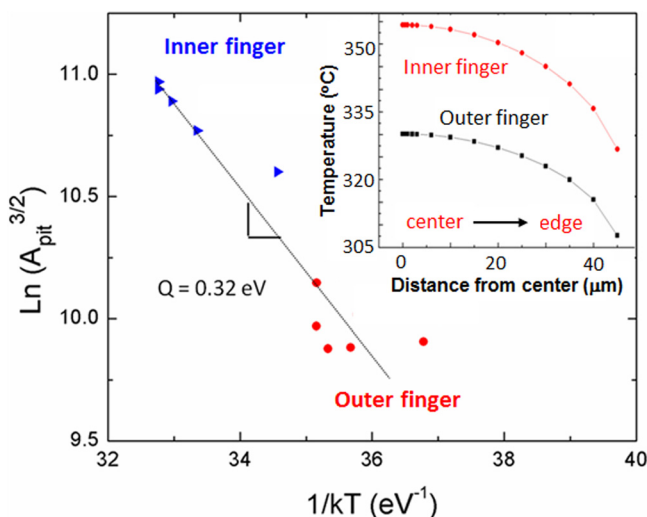
The inset of Figure 5 shows simulated thermal profiles of the device under stress conditions. These simulations were carried out using the ANSYS thermal analysis system (TAS), as described in Ref. 21. The lowest temperature of the inner finger was very close to the highest temperature of the outer finger. This is due to better heat dissipation in these locations. Correlation of the data of Figure 4 and the simulated temperature profiles supports the conclusion that the pit formation process is accelerated at higher temperatures.

Figure 5 shows the pit area to the 3/2 power versus the calculated temperature, in the form of an Arrhenius plot. If the pits are assumed to all have the same shape (e.g., right circular cones with fixed ratios of the radius to depth),  $A_{\text{pit}}^{3/2}$  scales with the pit volume. If the rate limiting mechanism for growth of the pits is field-induced diffusion away from the gate edges, the steady state flux away from the pit will scale with the diffusivity, and therefore with  $\exp(-Q/kT)$ , where  $Q$  is the activation energy for the rate-limiting diffusive process. The volume will also decrease at a constant rate, so that the data in Figure 5 should fall on a straight line. The reasonable fit of the data to this model supports the models underlying assumptions. The calculated activation energy in Figure 5, 0.32 eV, corresponds to the activation energy for the diffusive process involved. This is a reasonable value for surface diffusion.

FIG. 5. Pit area to the 3/2 power as a function of temperature. The data exhibit a thermally activated behavior with an activation energy of 0.32 eV. The inset is the estimated temperature as a function of position during electrical stressing. The temperature decreases gradually from the center to the edge. The temperature of the outer finger was significantly lower than that of the innercenter finger.

The observations discussed above confirm that the physical damage is accelerated at high temperatures caused by self-heating, and that the location of damage and heating vary in a correlated way. The larger degradation seen at the center suggests that structural degradation is not driven by current or hot carrier effects because the current density and hot electron density at the center should be lower than at the periphery due to the higher channel temperature. This is consistent with separate experiments on similar devices previously tested in our lab.<sup>6</sup>
